AFML-TR-76-81-PT-4

DEFECT-PROPERTY RELATIONSHIPS IN COMPOSITE MATERIALS

K. L. Reifsnider, E. G. Herneke, II and W. W. Stinchcomb

Final Report

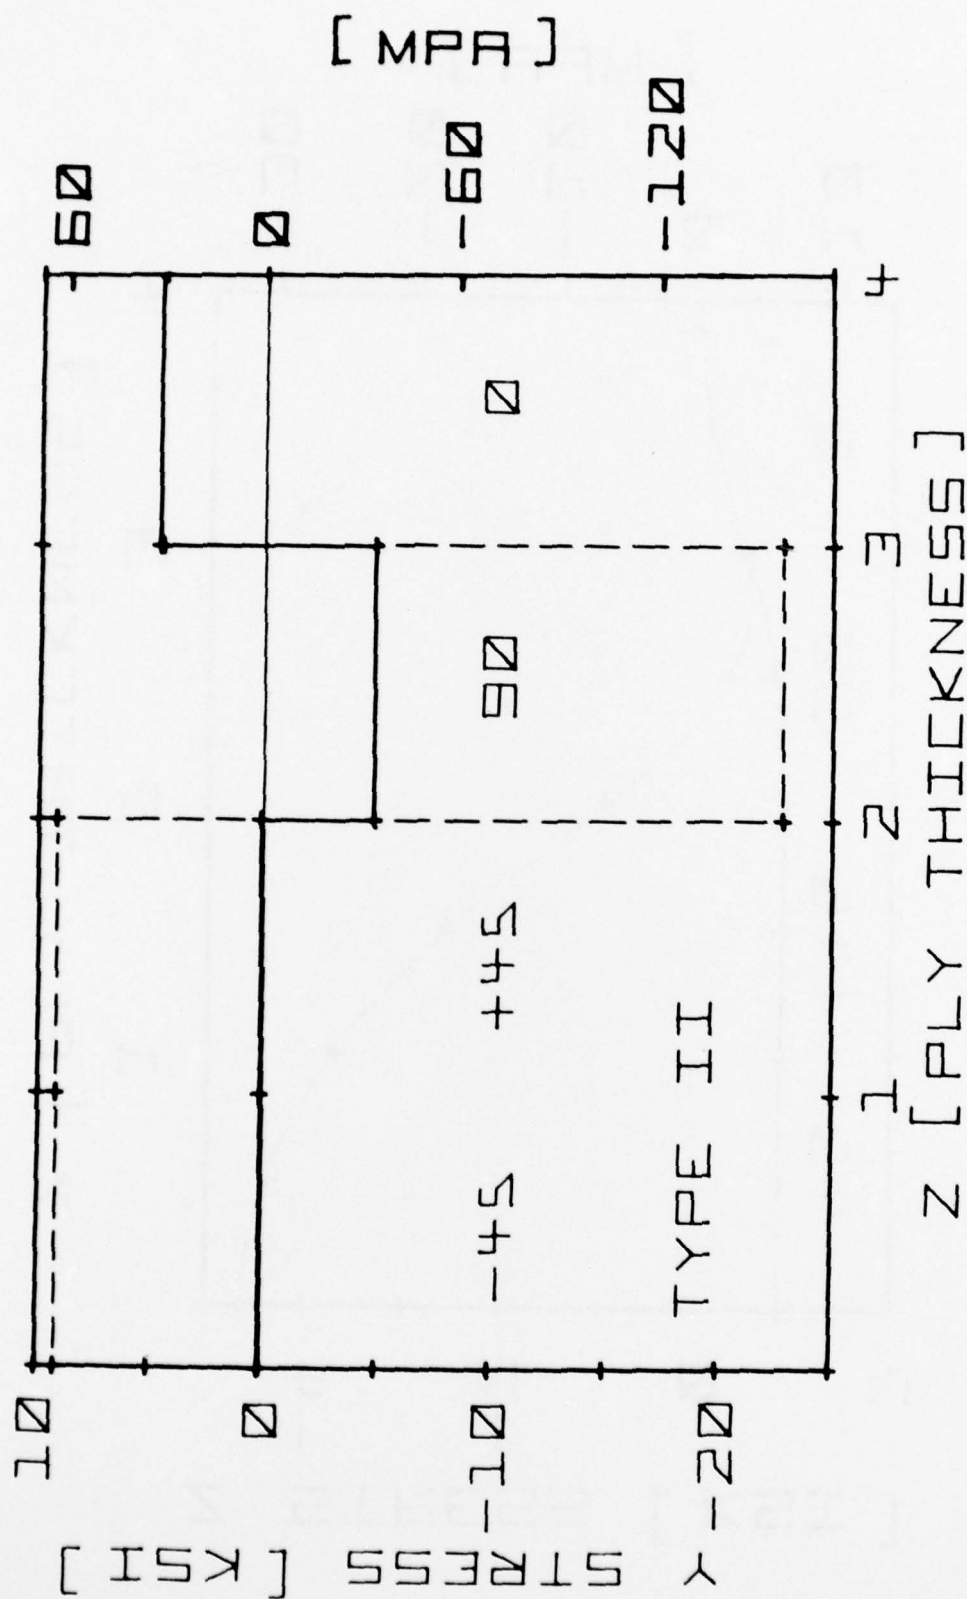
Figure A3. Transverse in-plane normal stress in a  $[0,90,\pm45]_s$  laminate. Solid lines show thermal residual stresses while dotted lines show the stresses under a 4.45 kN applied load.
